BUILDING SCIENCE SERIES 40

Engineering Aspects of the 1971 San Fernando Earthquake

This report presents the observations of the NBS on-site inspection team (most photographs in this report were taken by the team). The material presented herein is intended to serve as (1) a documentation of damage resulting from the earthquake and (2) as a source document for further studies, research, and recommendations. This is particularly important as necessary remedial work and restoration have resulted in the removal of evidence that is essential for studies and evaluations.

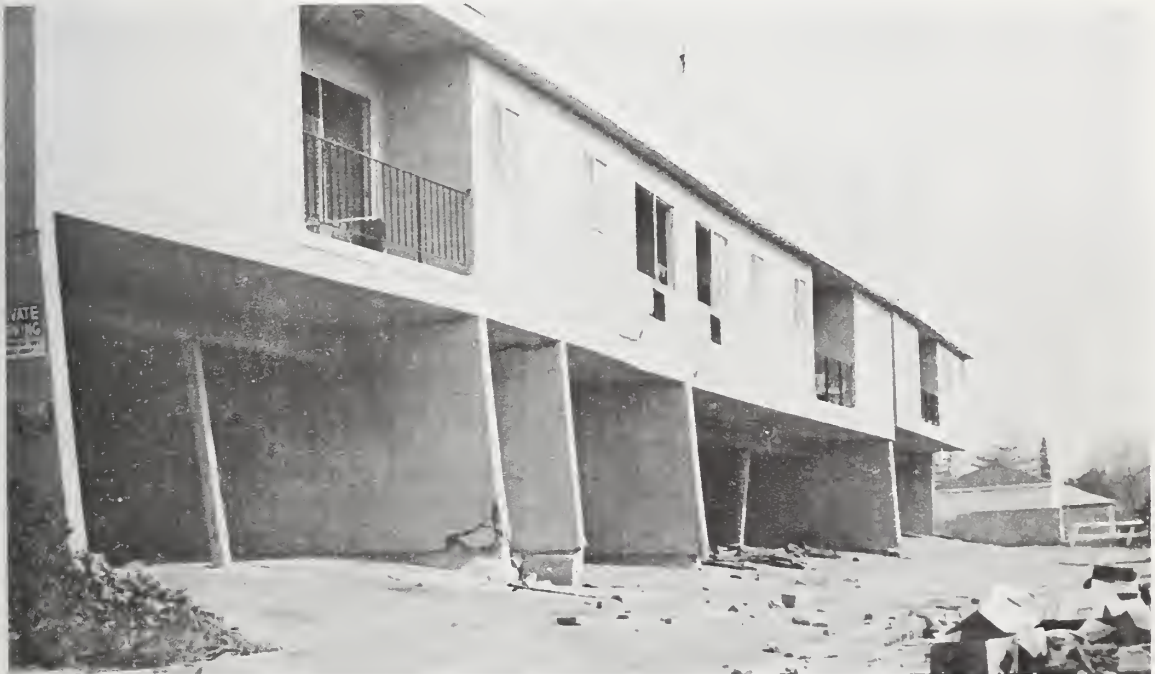
Figure 5.171 Rear view of damaged two-story Mardette apartment building.

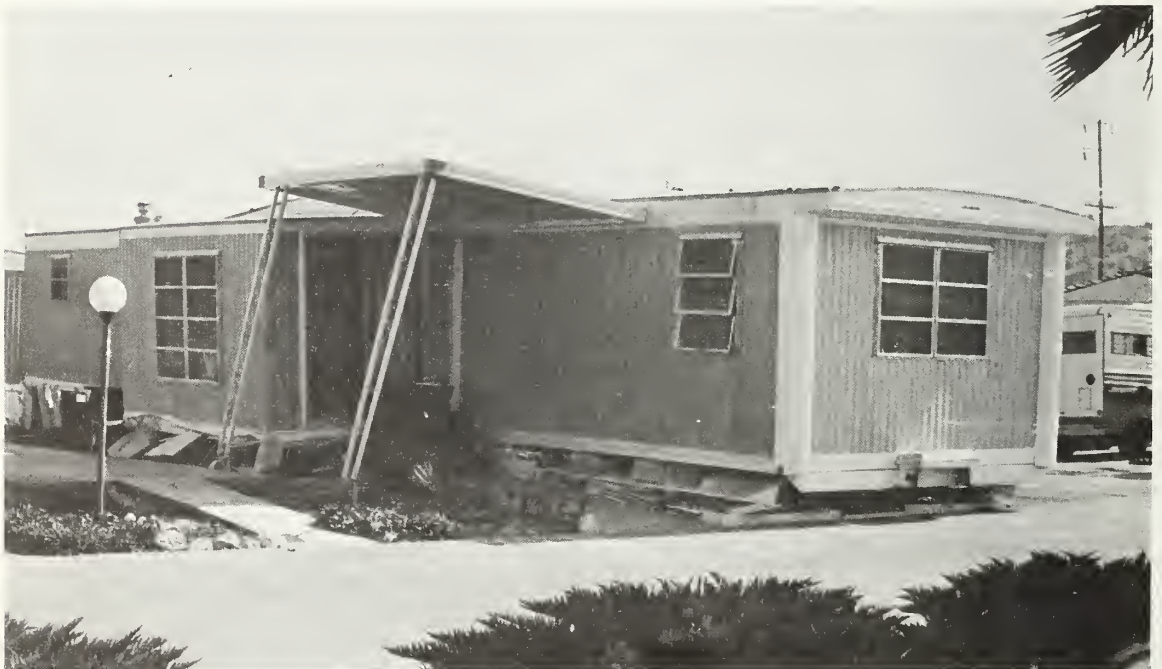
Typical damaged mobile homes are shown in figure 5.173 (map 2, location 1) and figure 5.174 (map 2, location 3). These homes are usually supported on small concrete or metal base supports. Metal curtain walls around the base were usually damaged when trailers moved sideways (there is little to resist lateral movement since these homes are usually not attached to the base supports). Frequently considerable damage was caused by the supports subsequently punching through the floor.

Figure 5.173 Mobile home (Soledad Canyon Road, Newhall) which was damaged when it fell off its small concrete and metal base supports.

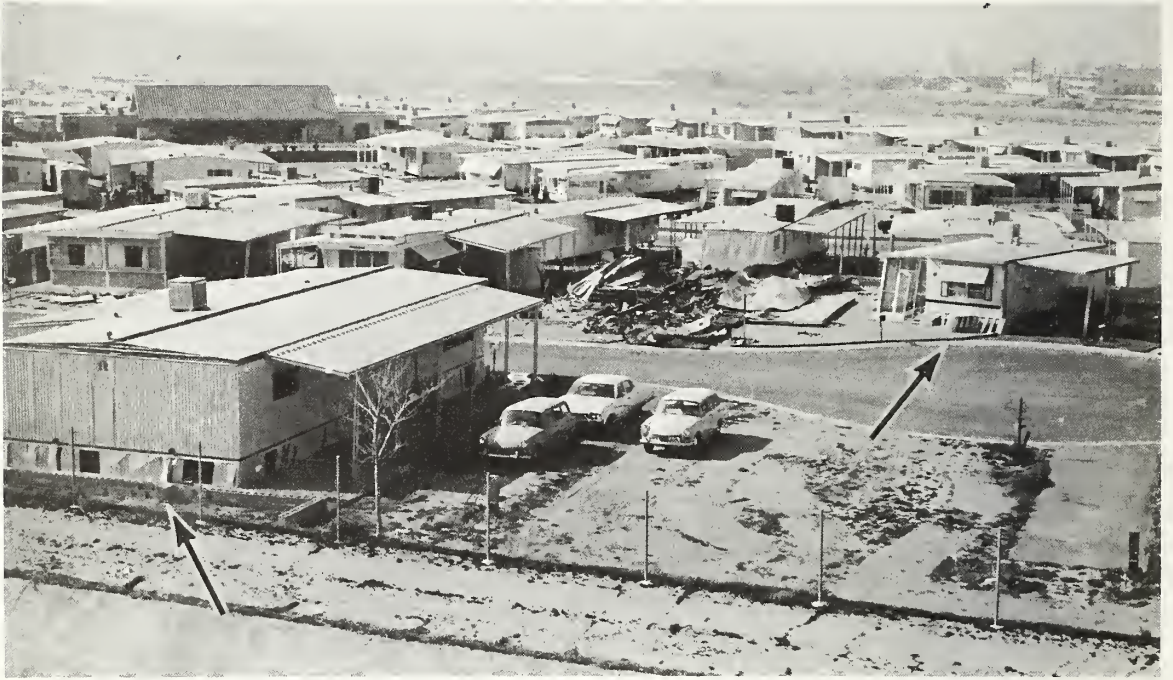
Figure 5.174 Mobile home park located along Sierra Highway 14 in Newhall. At the center of the figure are the remains of a home which was completely destroyed by fire. Note damaged metal curtain walls around the bases of the mobile homes (arrows).

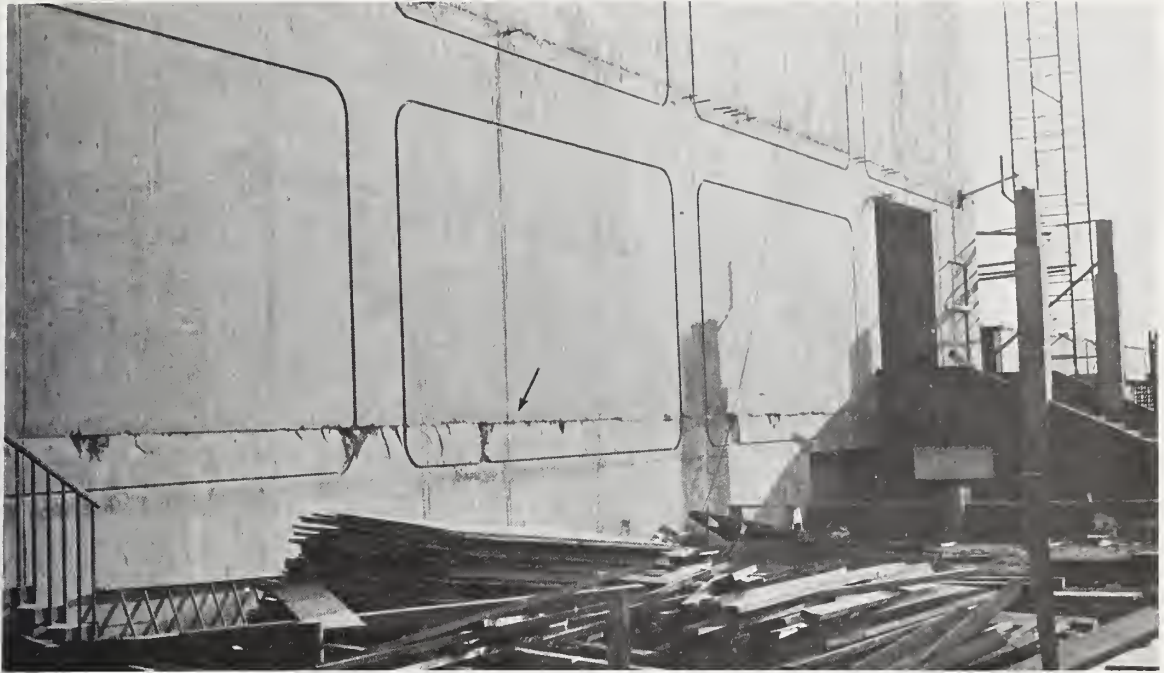
Damage noted on the building exterior consisted primarily of horizontal cracks and concrete spalling along the construction joints (fig. 5.176 and 5.177) and at the building corners (fig. 5.178). The penthouse free-standing cantilever concrete walls were only 12 hours old at the time of the earthquake but suffered no damage.

Figure 5.176 Horizontal crack along the construction joint at the base of the structure.

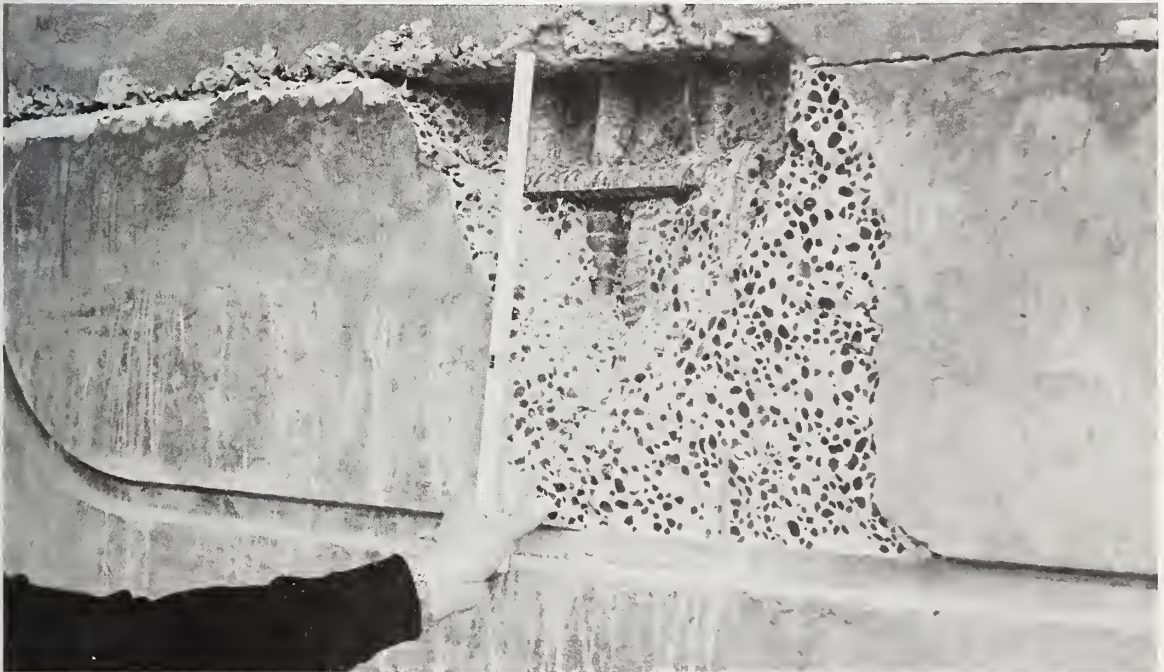
Figure 5.177 Damage to the exterior surface of the concrete wall along the construction joint.

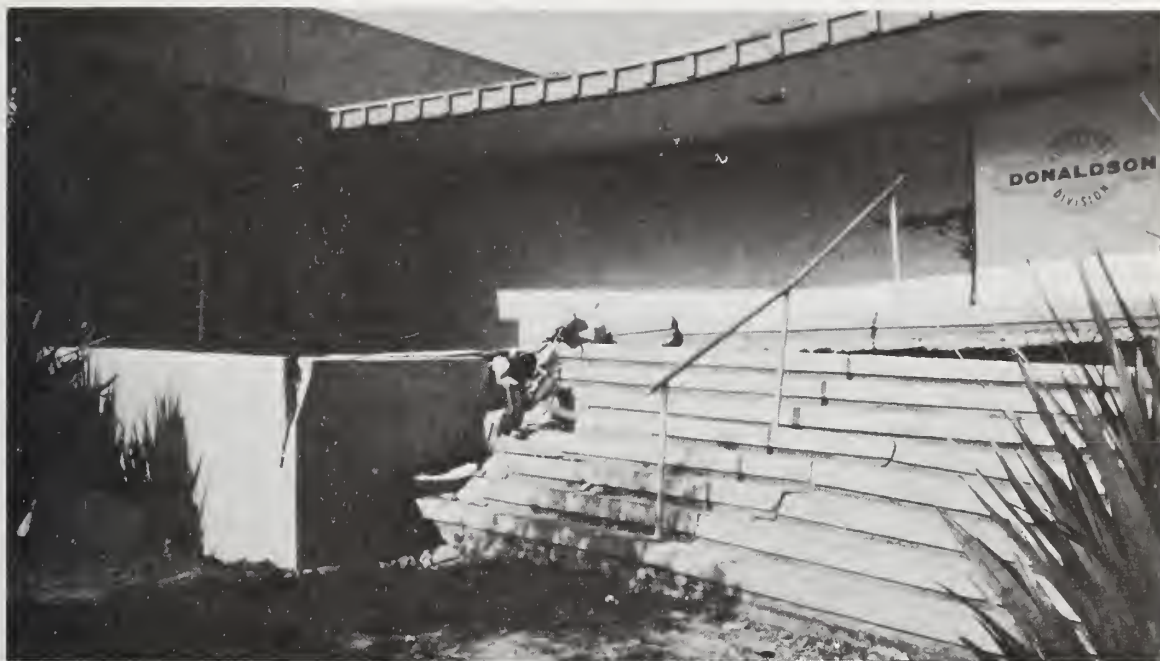
Figure 5.181 Ground displacement caused separation of two walls.

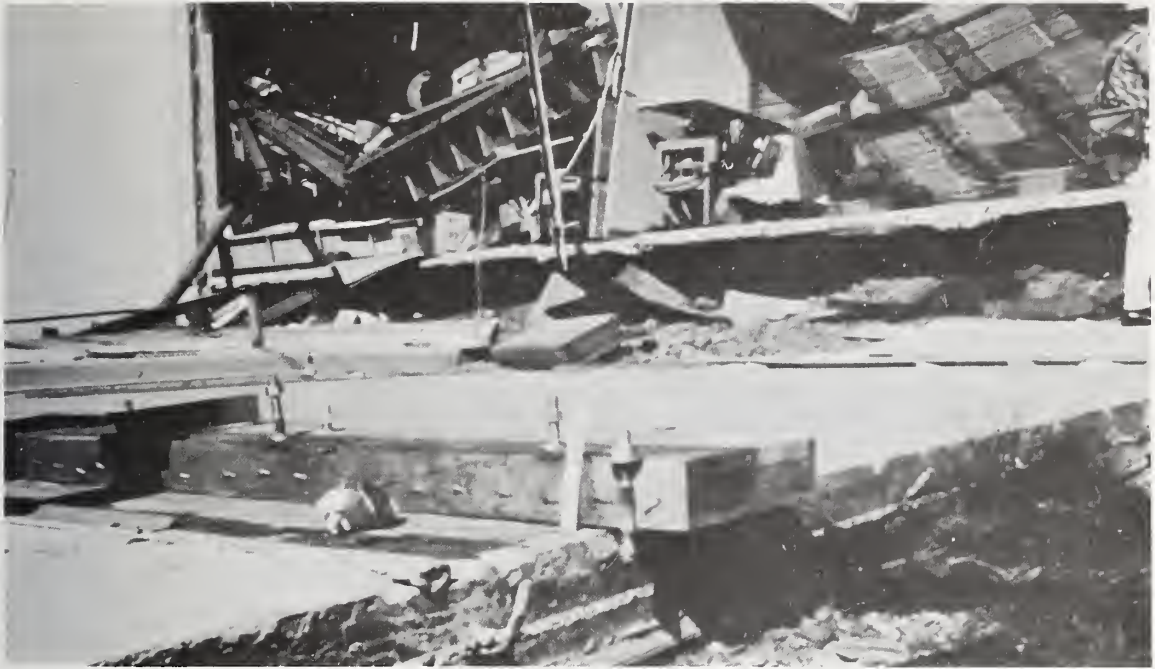
away from the roof and floor, thereby causing the roof to collapse. A typical failure is shown in figure 5.182.

Figure 5.182 The roof collapsed when the exterior wall pulled away.

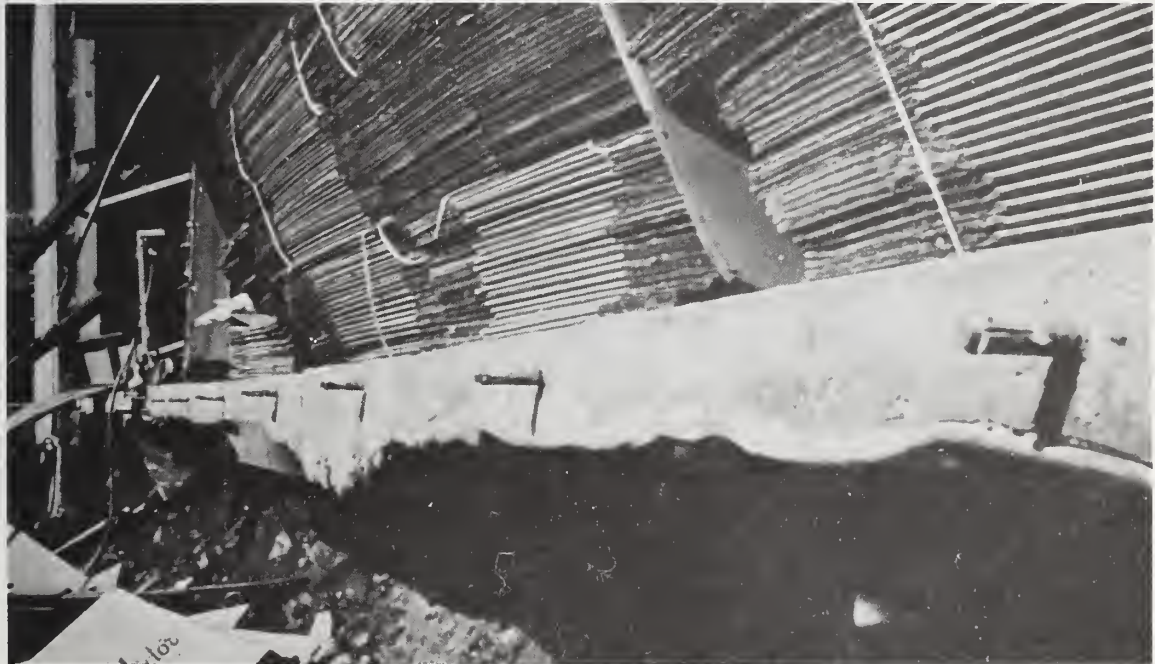
The performance of drilled-in anchors can be inferior to cast-in anchors or to anchor bolts in resisting tensile forces since the strength is dependent on the quality of installation. Typical evidence of failure of drilled-in anchors is seen in figure 5.183. The drilled-in anchors in the wall, which were used to connect reinforcing dowels at the floor level, failed thereby contributing to the exterior wall collapse.

Figure 5.183 Typical failure of drilled-in anchors.

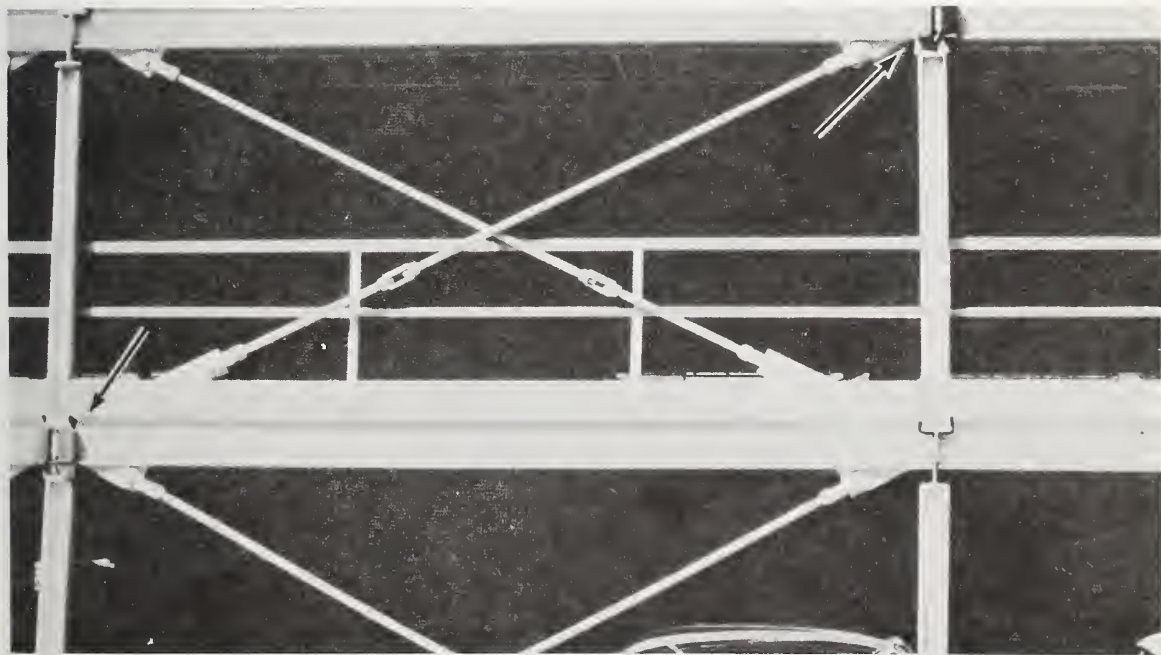
Damage to the structure was confined to web crippling of some of main floor beams to which diagonal braces were attached. Positions of damaged beams with respect to diagonal braces and a close-up view of a damaged beam are

Figure 5.185 Location of damaged floor beams (arrows).

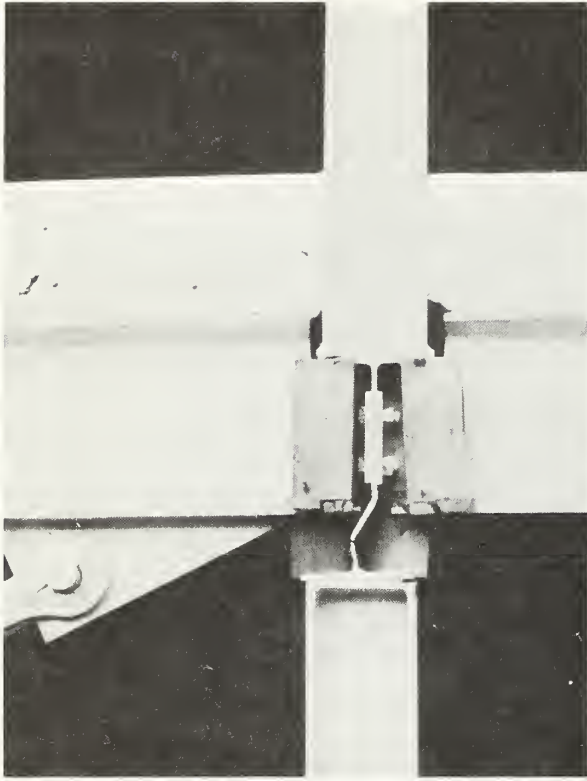
shown in figures 5.185 and 5.186. It is clear from these photographs that no vertical stiffeners were provided at the support. Figure 5.187 shows a typical repaired beam. Two vertical stiffeners were added to the beam and bottom half of the crippled web and the flange was replaced with a new section over the support. Initial installation of vertical stiffeners at a cost far less than the repair cost could have prevented the web from crippling.

Figure 5.186 Close-up of damaged floor beam. Wood blocks were used to provide temporary support.

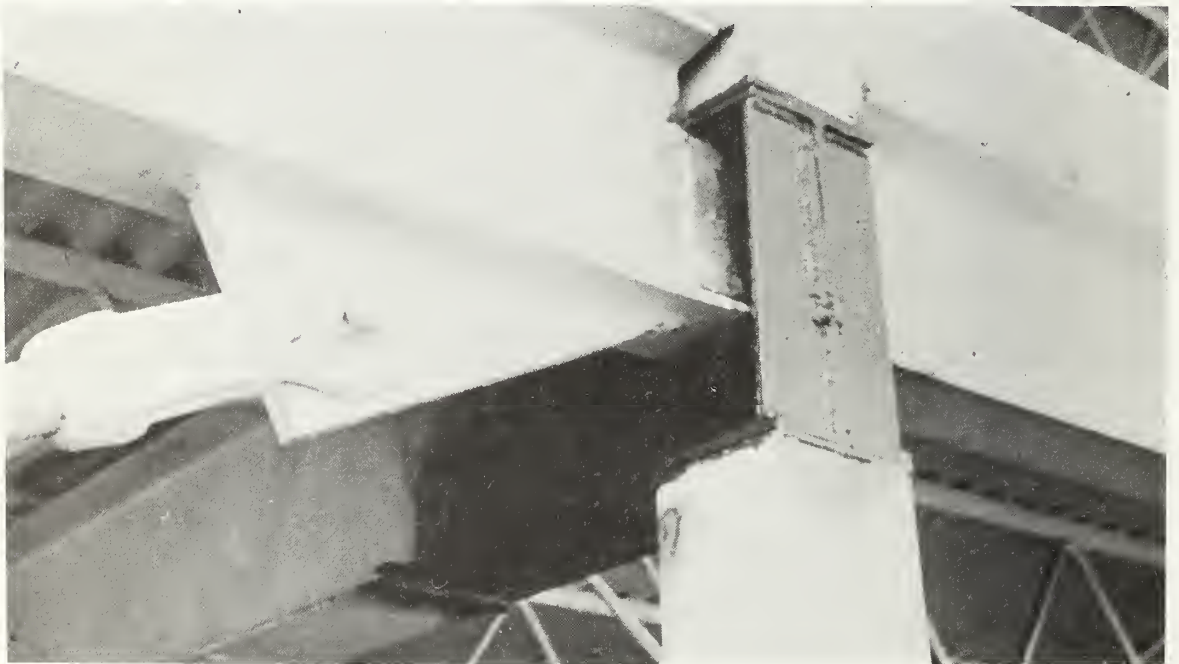
Figure 5.187 Repaired floor beam. The bottom half of the beam near the support was repaired with a new section and two bearing stiffeners were added.

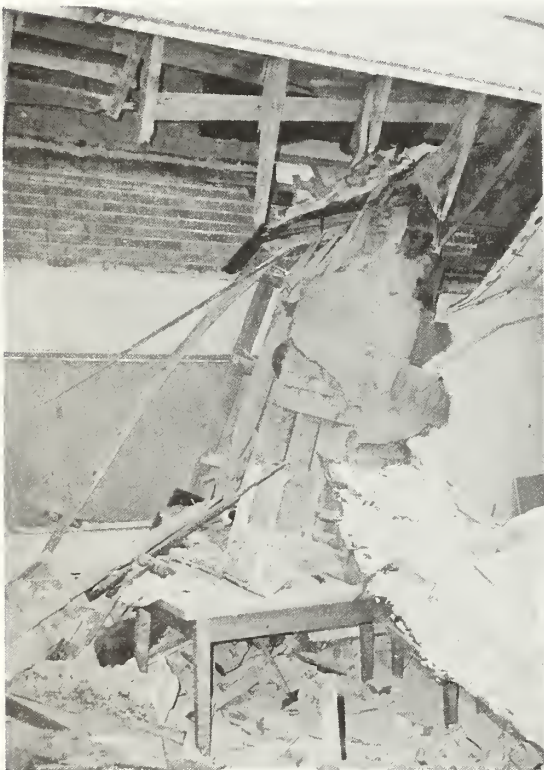
Figure 6.3 A portion of the parapet wall fell through the roof and came to rest on a table, Los Angeles High School.

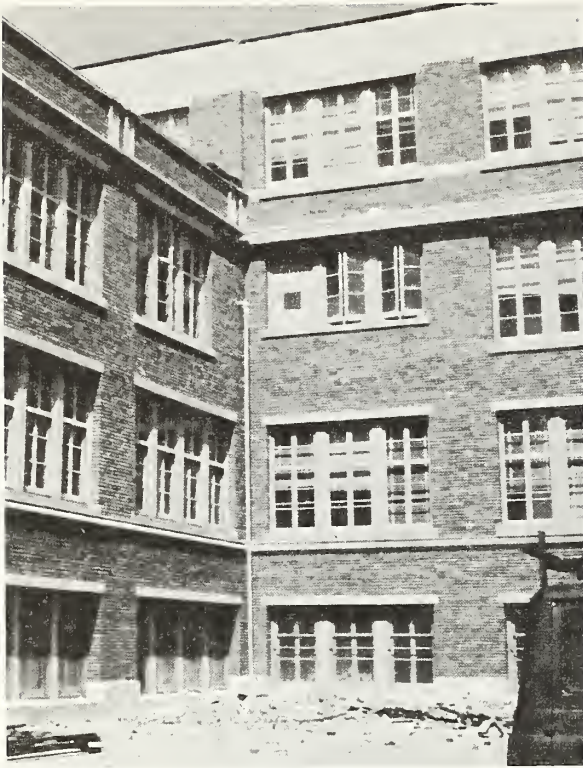
Figure 6.4 Brickwork fell from the parapet into the courtyard, Los Angeles High School.

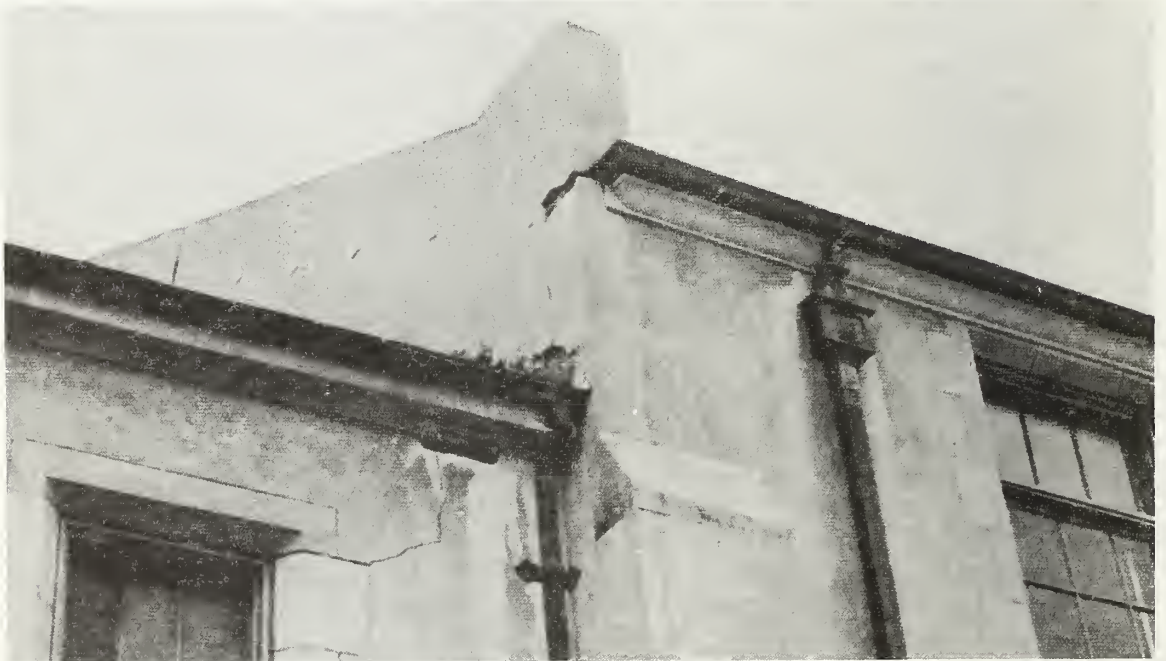
Figure 6.5 Brick walls sustained serious cracking, Morningside School Building #2.

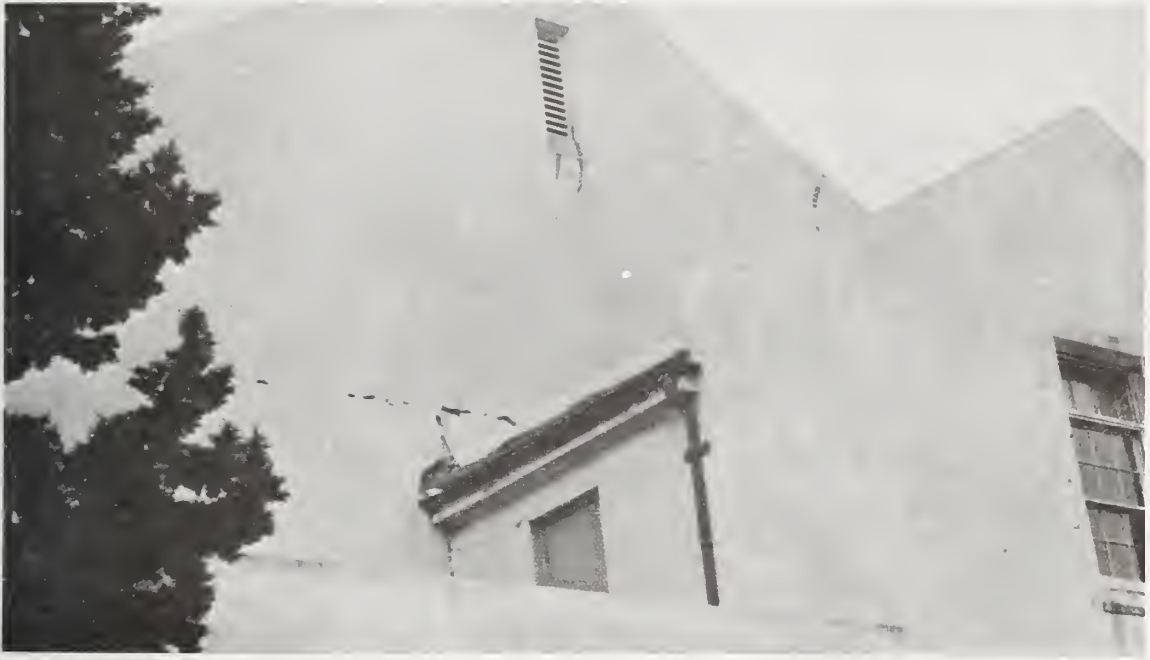
Figure 6.6 Brick wall was displaced at the gable end, Morningside School Building #2.

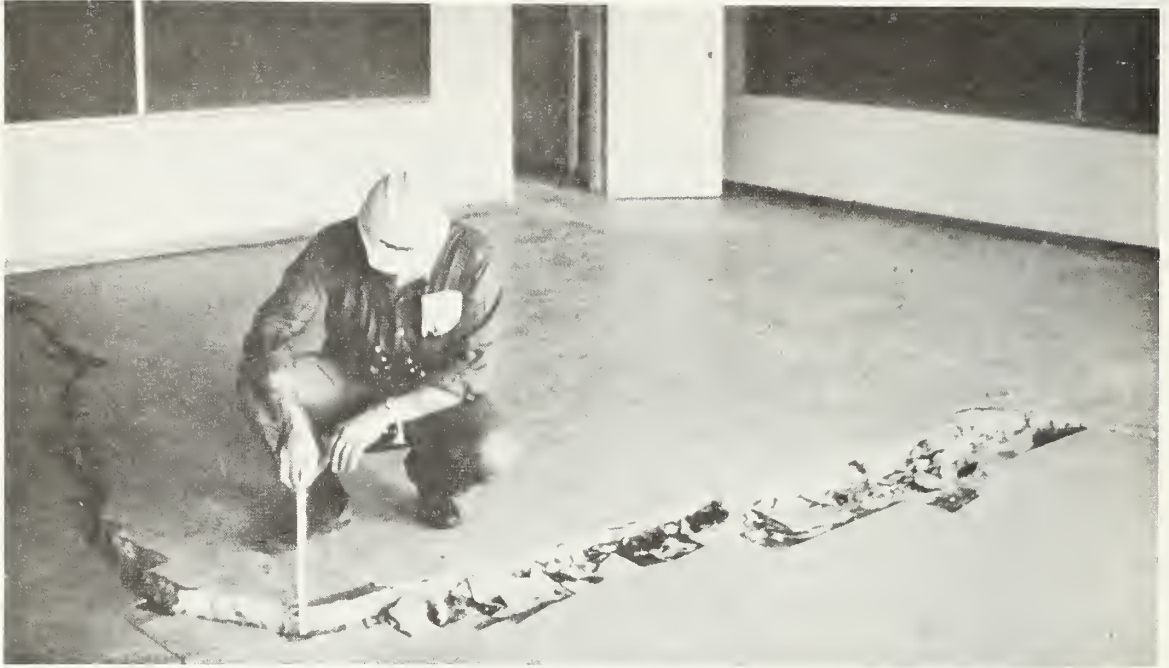
There was minor structural damage to the walls and slab on grade. The slab cracked in two classrooms, presumably located directly above ground rupture, with a vertical displacement of approximately 3 1/2 in (fig. 6.8). The walls

Figure 6.8 Cracked slab with a vertical displacement of approximately 3 1/2 inches, Harding Street School.

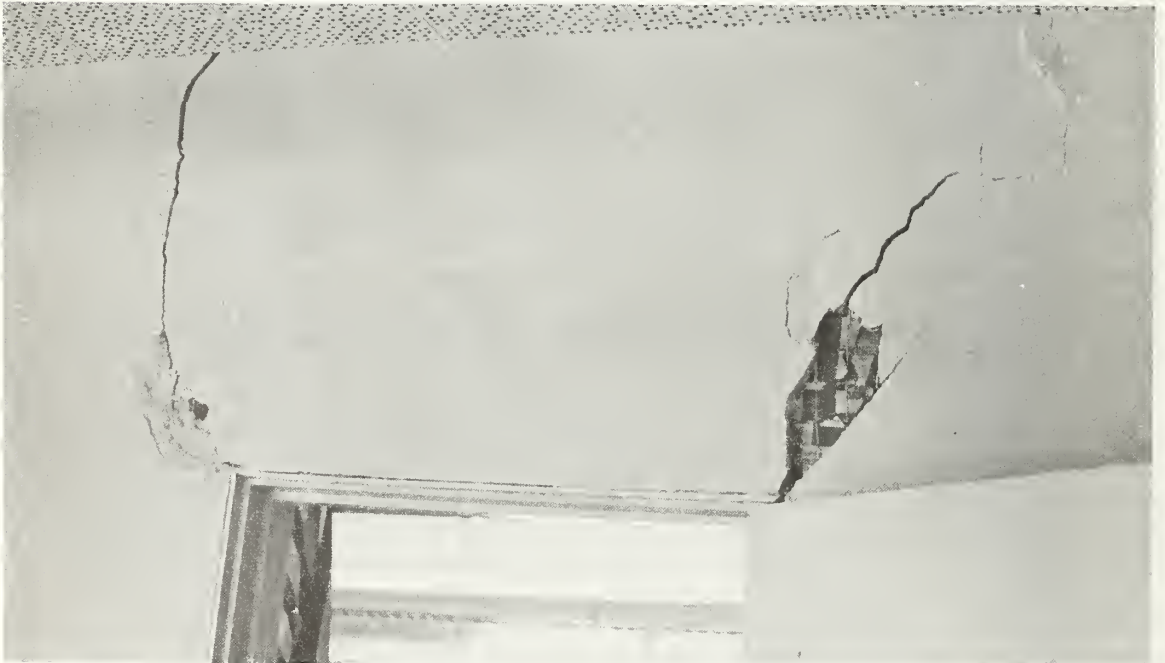
racked slightly causing some doors to bind in the steel frames (fig. 6.9). There was also plaster cracking. The two classrooms in which the floor was cracked were repaired. The entire school is occupied.

Figure 6.9 Plaster cracks over door at Harding Street School. Racking of wall caused doors to bind in the steel frames.

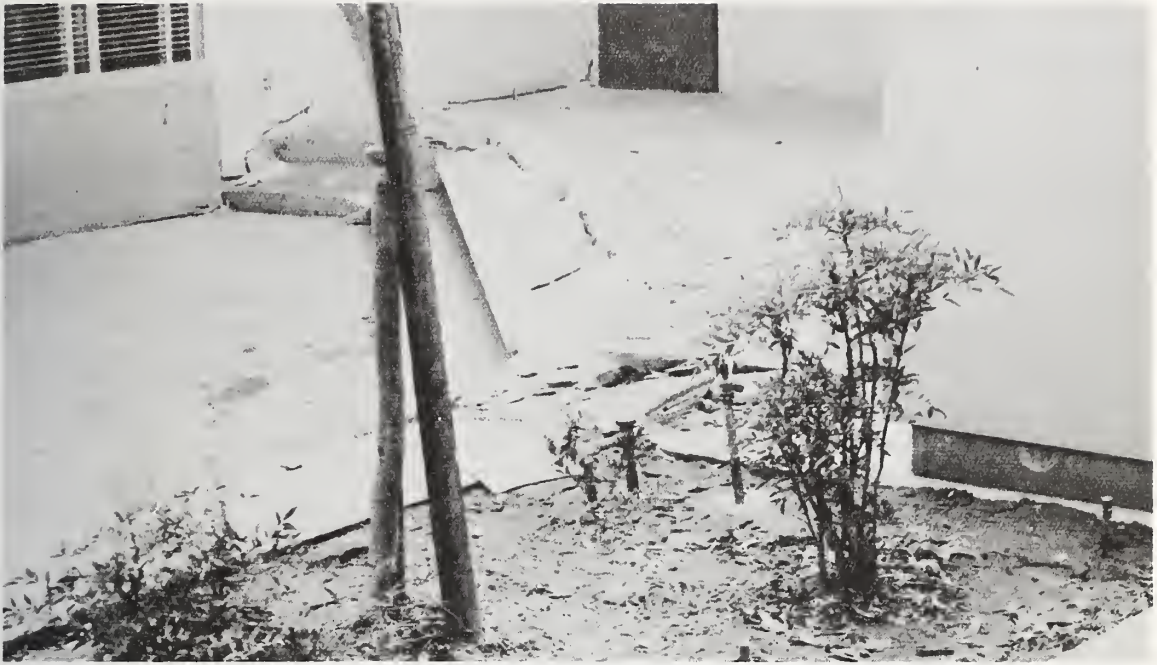
Figure 6.10 Buckled slab on grade at Van Gogh Street School.

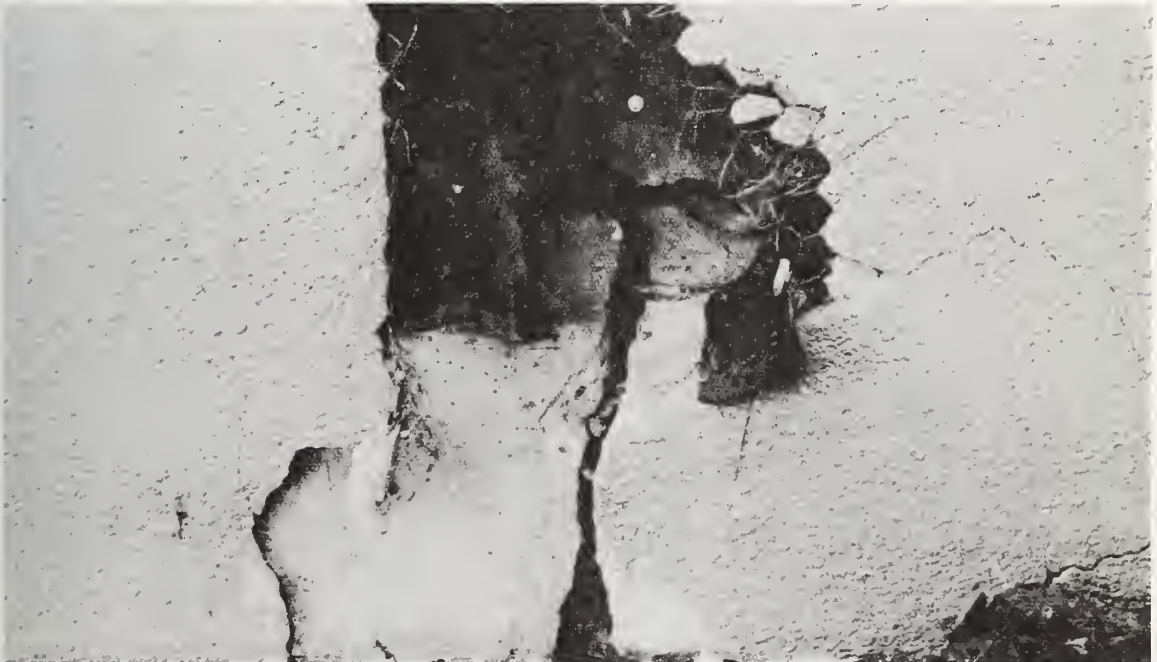
Figure 6.11 Fractured concrete foundation wall, Van Gogh Street School.

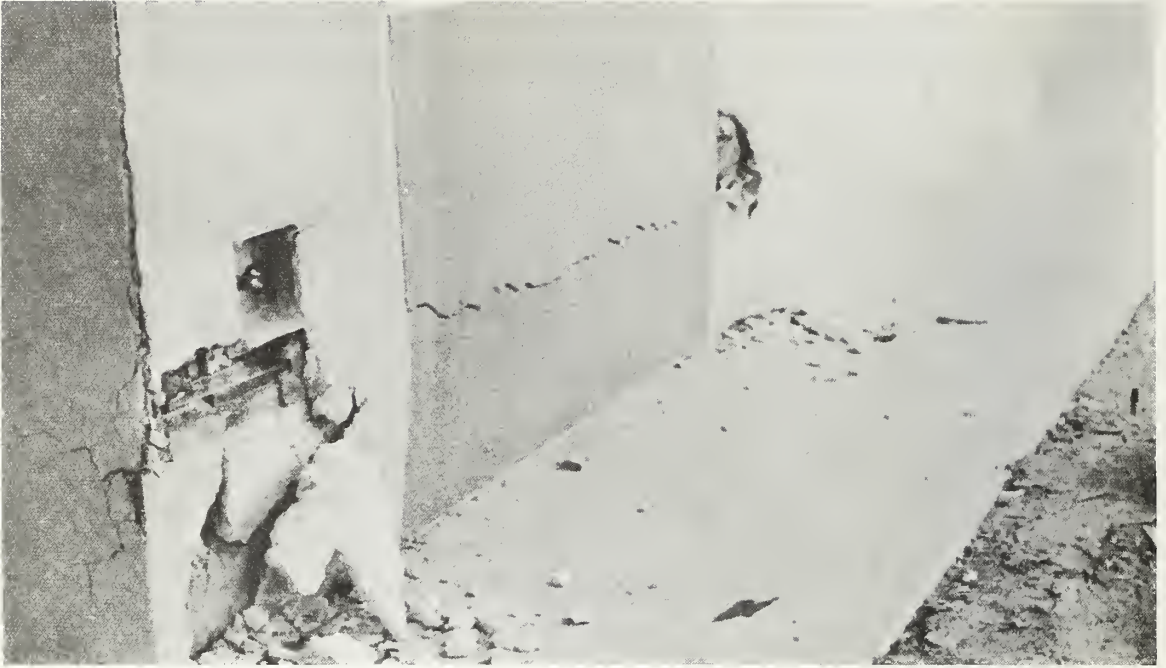
Figure 6.12 Displaced bearing wall, Van Gogh Street School.

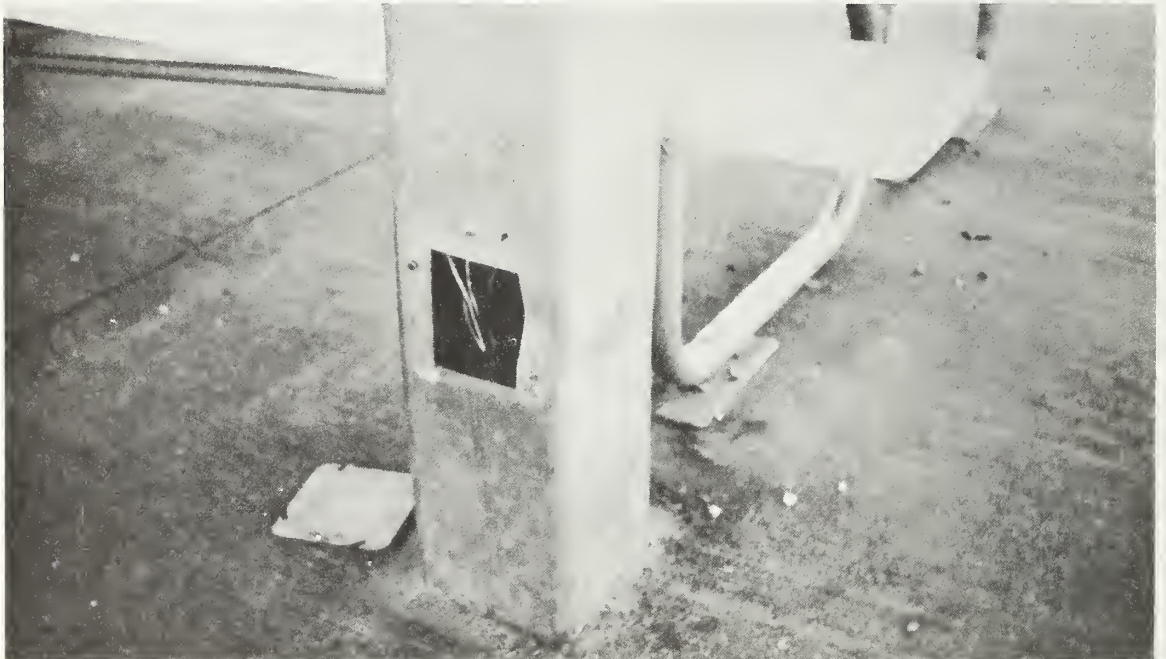
Figure 6.13 Lunch shelter columns were permanently bent at opening for electrical outlet box, Van Gogh Street School.

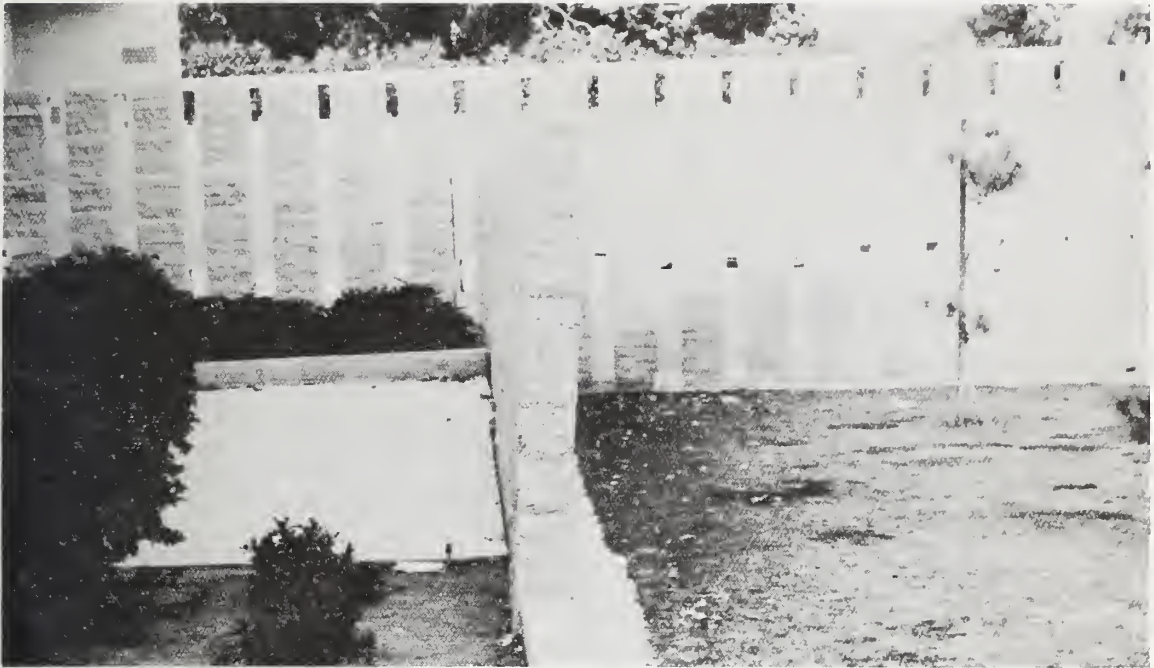
Figure 6.14 Cantilever concrete block garden wall leaned approximately ten degrees, Van Gogh Street School.

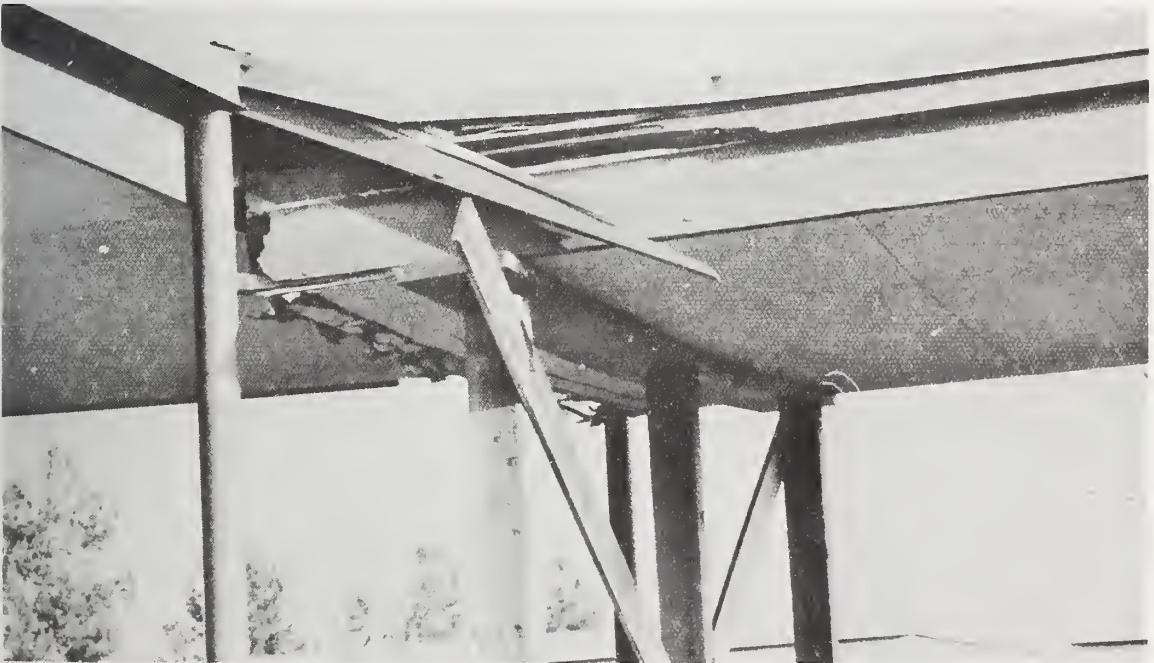
Principle structural damage was caused by the differential stiffness of the buildings and the covered arcades. The arcades pulled loose both from the buildings and from each other and distorted their supporting pipe columns (fig. 6.15 and 6.16). There was a slight spalling of the gymnasium prestressed-concrete roof member where a steel cross beam was attached to support gymnastic equipment (fig. 6.17). The ground under the gymnasium subsided approximately 1 1/2 in leaving a void beneath the slab on grade adjacent to the

Figure 6.15 Arcades pulled loose from each other at Sylmar High School.

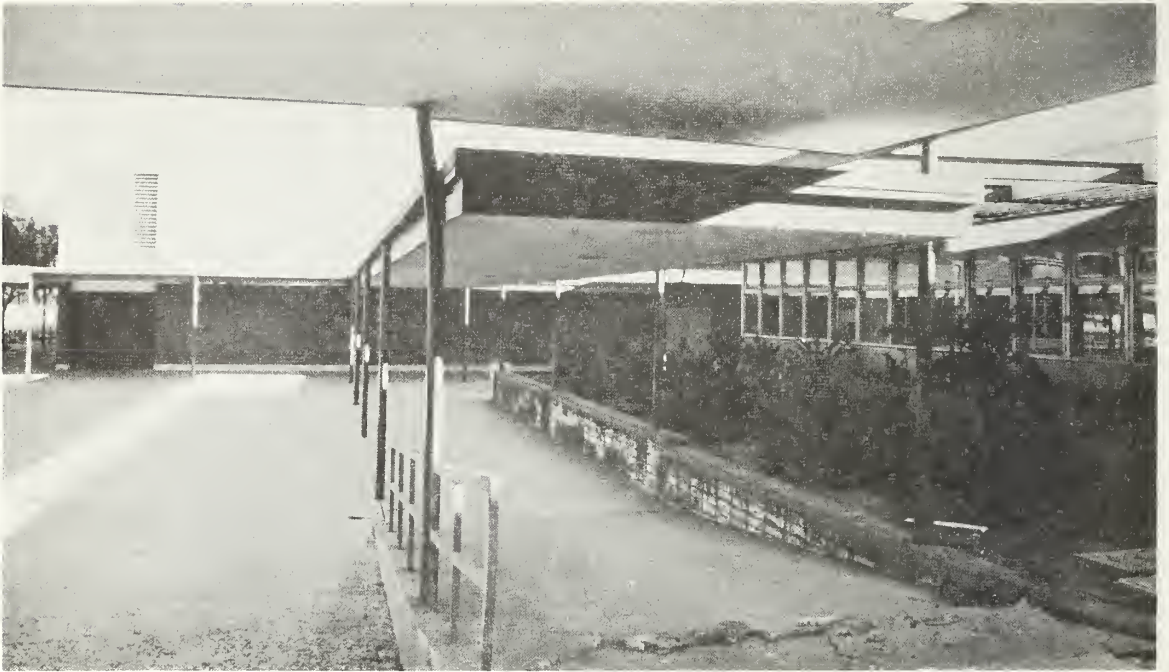
Figure 6.16 Distorted pipe columns at arcade, Sylmar High School.

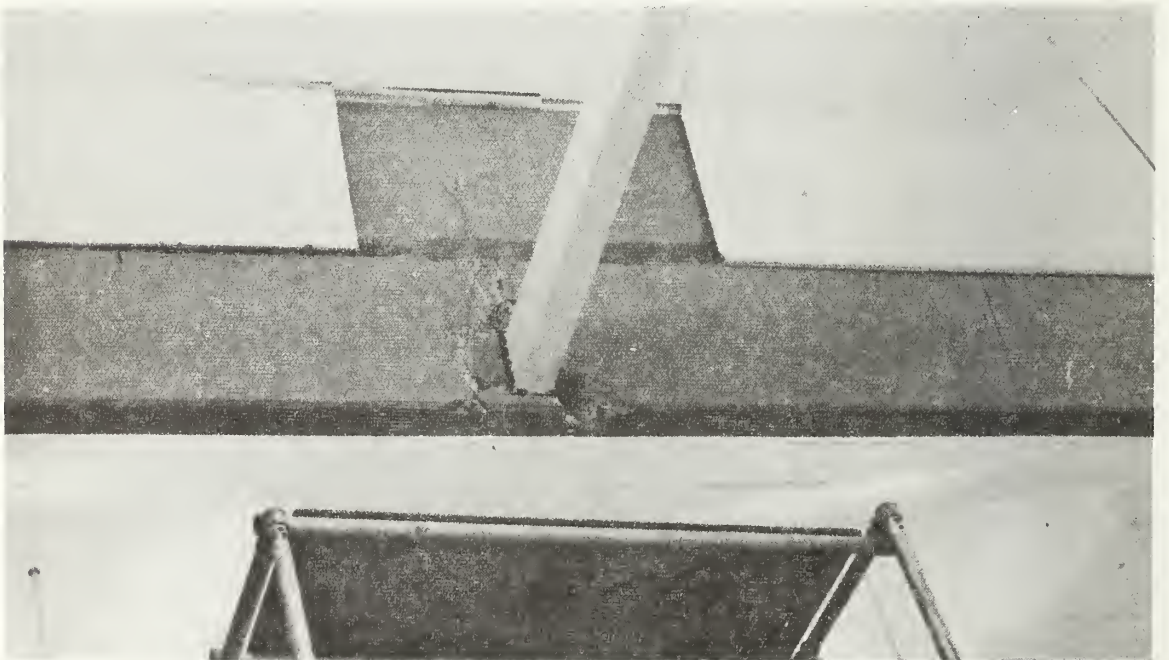
Figure 6.17 Spalled prestressed concrete roof member at gymnastic equipment support, Sylmar High School.

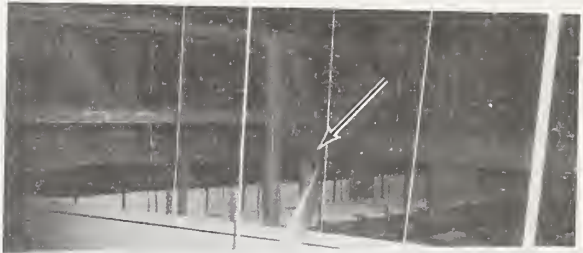
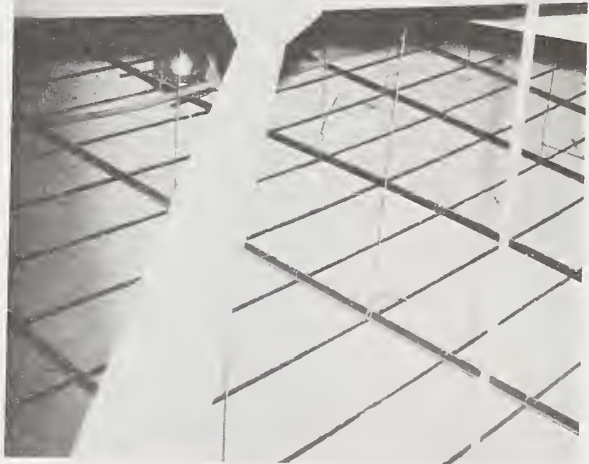
Figure 6.21 Buckled 5 x 3 angle brace, San Fernando High School.

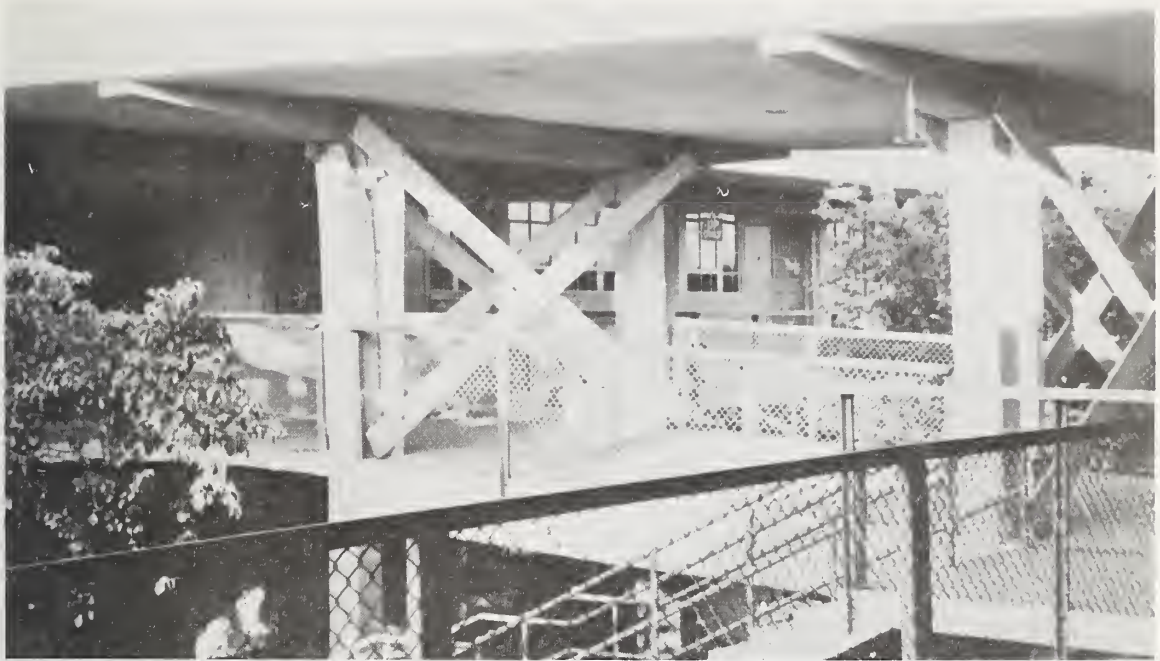
The major structural damage consisted of fracturing of four second-story columns of a two-story covered arcade (fig. 6.22 and 6.23). The concrete roof of the arcade was shored to prevent collapse. The longitudinal concrete wall in the classroom buildings, extending the full length of the buildings sustained some hairline diagonal cracks near both ends of the building. The cracking can be attributed to shrinkage stresses that existed prior to the earthquake. A concrete curb at the corner of the mechanical penthouse fractured under the steel column at the brace connection (fig. 6.24 and 6.25). Structural damage was minimal; however, a major loss of lighting fixtures constituted a real hazard. Approximately 1500 lighting fixture stems failed at the ceiling canopy or at the fixture. All fixtures have been reinstalled. There was nominal damage to acoustical ceiling tile. Electrical conduits were damaged at structural separation joints where they were rigidly connected to both sides (fig. 6.26). The earthquake aftershock of March 31, 1971, caused little additional damage. There were a few new plaster cracks, a few damaged ceiling tiles, and some additional flaking of concrete on the previously damaged arcade columns. It is possible that the aftershock could have caused collapse of the arcade if it had not been shored. The damaged arcade has been removed. The entire school is in use.

Figure 6.22 Fractured concrete at second-story covered arcade columns, Patrick Henry Jr. High School.

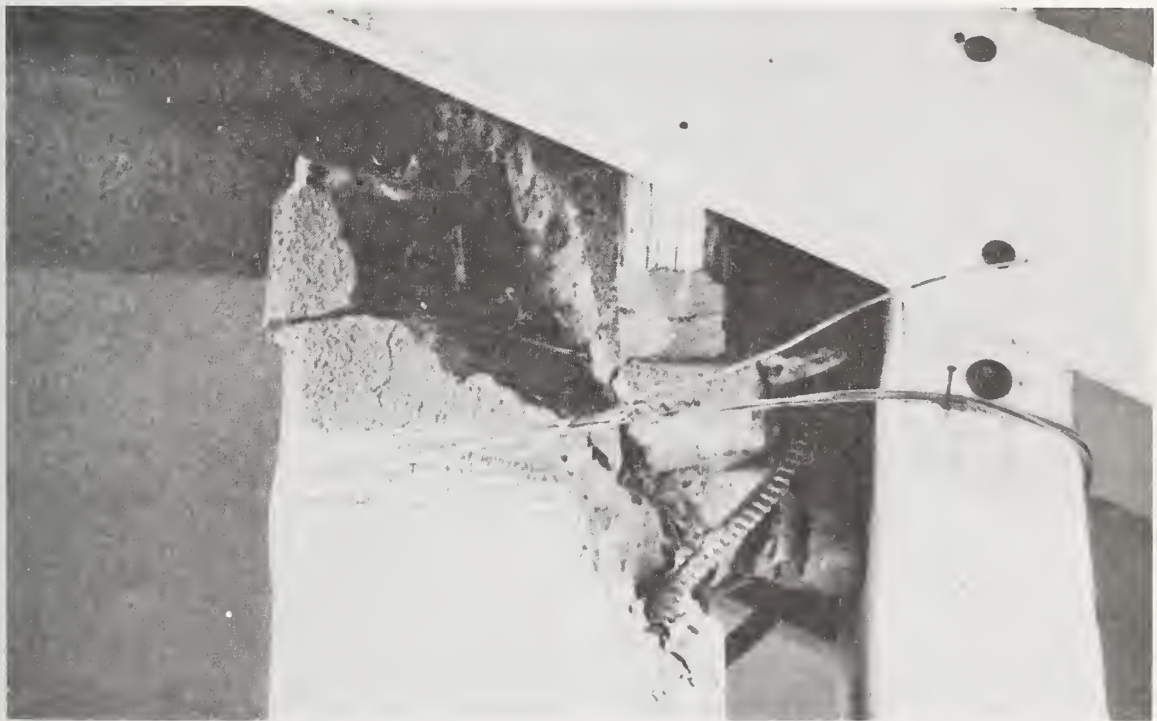
Figure 6.23 Close up of fractured concrete second-story covered arcade column, Patrick Henry Jr. High School.

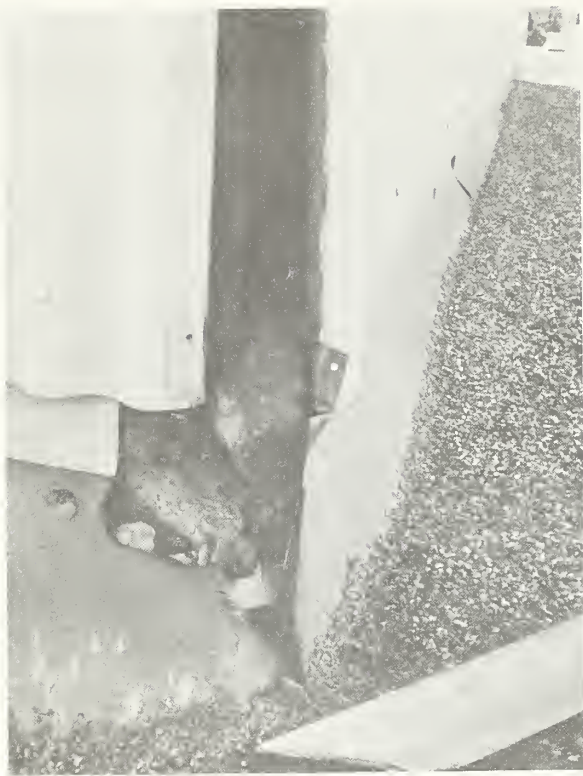
Figure 6.24 Corner of mechanical penthouse fractured under steel column (exterior view), Patrick Henry Jr. High School.
